Region 9 Enforcement Division
75 Hawthorne Street
San Francisco, CA 94105

Inspection Date(s):	9/30/15		
Time:	Entry: 1:00pm	Exit: 2:15pm	
Media:	Water		
Regulatory Program(s)	Clean Water Act NPDES /CAFO Dairy		
Company Name:	TIVA Dairy		
Facility or Site Name:			
Facility/Site Physical Location:	14761 Carpenter Ave., Ontario, CA, 91762		
Geographic Coordinates:			
Mailing address:			
Facility/Site Contact:	Dickie Vander Meulen	Title: Owner/Operator	
	Phone: [REDACTED]	Email:	
Facility/Site Identifier:	NPDES CAG018001 / Order R8-2013-0001, General waste discharge requirements for CAFOs (dairies and related facilities)		
NAICS:	112120 Dairy Cattle and Milk Production		
SIC:	0241 Dairy Farms		
Facility/Site Personnel Participating in Inspection:			
Name	Affiliation	Title	Email
Dickie Vander Meulen	TIVA Dairy	Operator	
EPA Inspector(s):			
John Tinger	EPA	Engineer	Tinger.John@EPA.gov
Federal/State/Tribal/Local Representatives:			
Edward Kashak	WRCB-R8	Engineering Geologist	ekashak@waterboards.ca.gov

SECTION I – INTRODUCTION

SANTA ANA REGIONAL WATER QUALITY CONTROL BOARD
INSPECTION REPORT

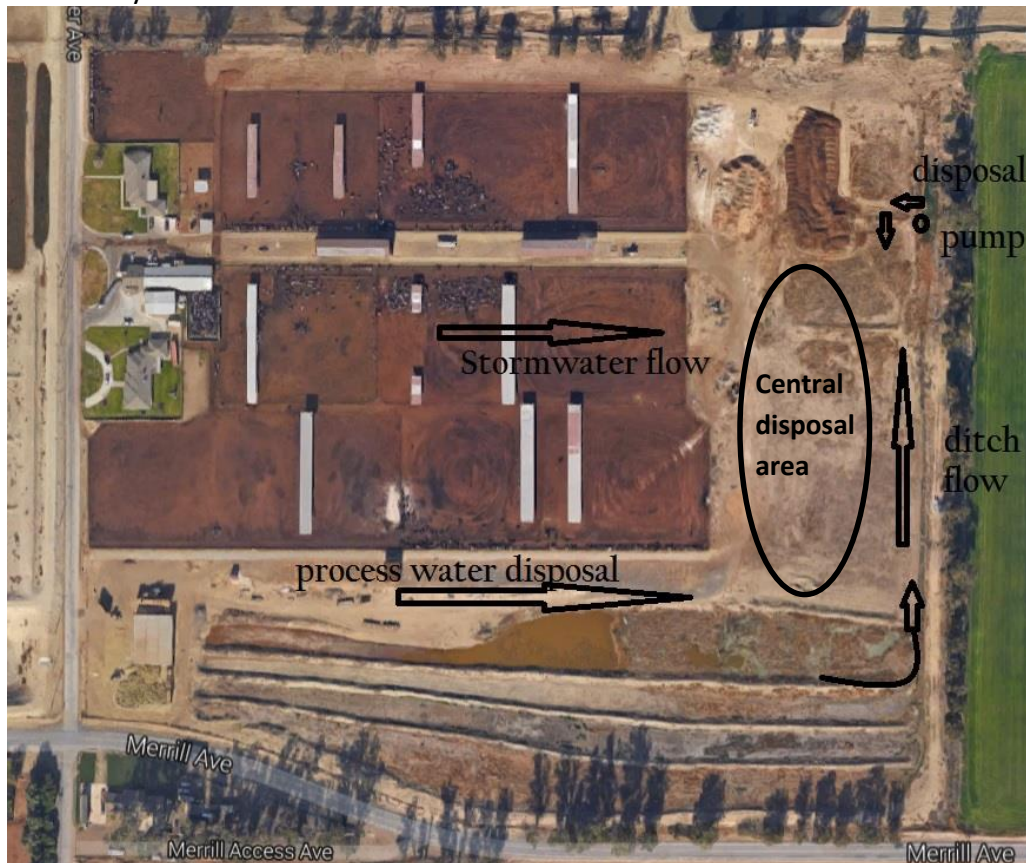
1 – Facility overview.

Washwater from the milking barn area gravity drains through underground pipes to the southern portion of the dairy where it is directed to one of 4 standpipes for discharge to the disposal area. The disposal area consists of 4 bermed areas which drain towards the eastern end of the facility. (see photo 1). The operator manually directs the wastewater to one of the 4 standpipes. At the time of the inspection, wastewater was actively flowing into the 2nd northernmost bermed area (photo 3). The operator stated wastewater has been directed to this bermed area for approximately 2 weeks. Previously, the northernmost bermed area had received wastewater (photo 4). At the time of the inspection, the solids in the northernmost area had been drying for approximately 2 weeks, and the operator stated he anticipates removing the solids within the month when the solids are sufficiently dry to accommodate equipment.

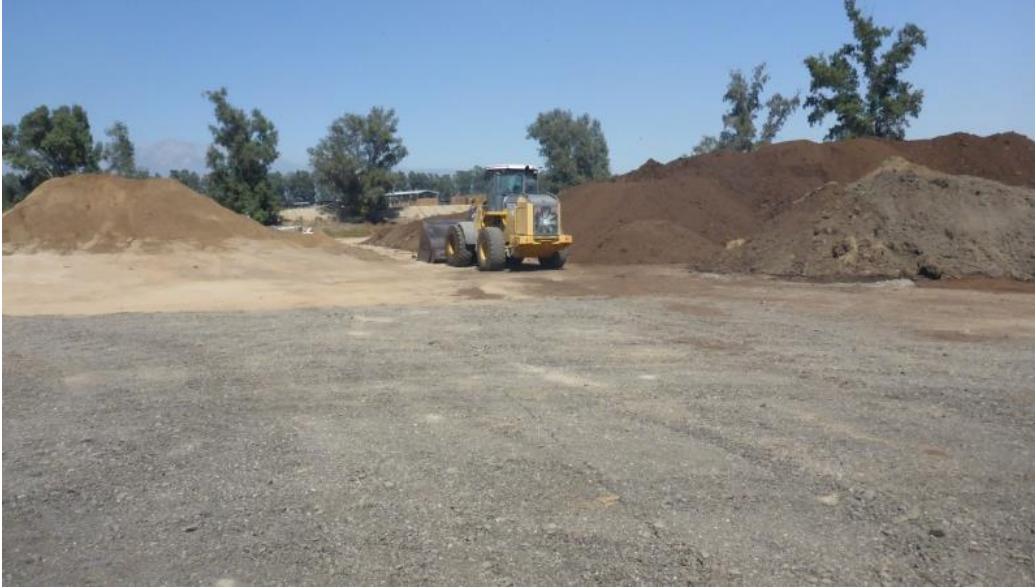
No issues noted. Stockpiles of manure did not appear to have been present for more than 180 days.

Photo 2: Manure stockpiling

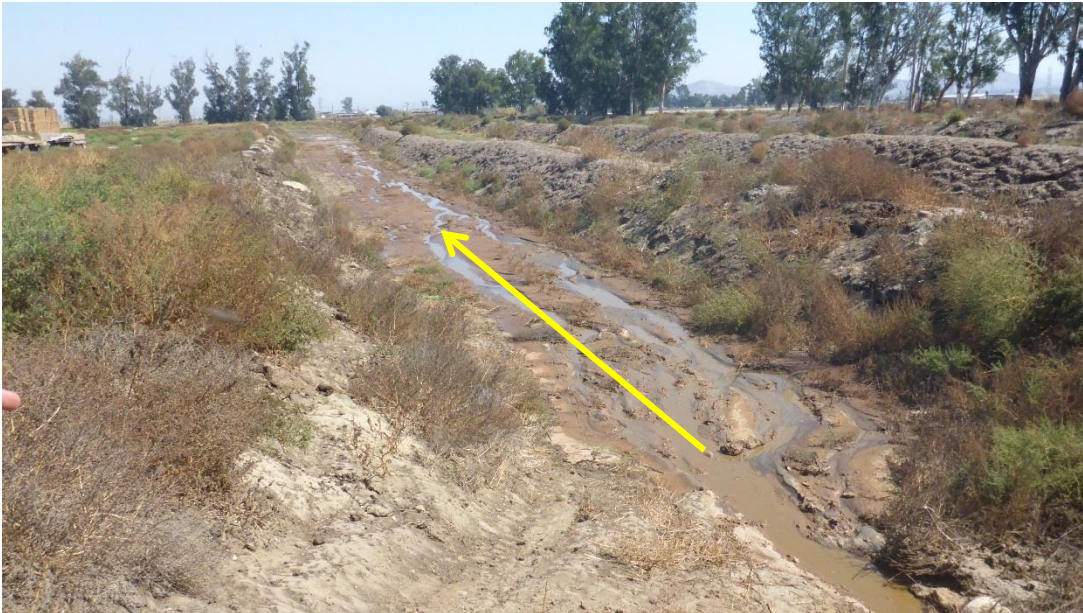
Photo 3: 2nd (from north) bermed area actively receiving washwater from standpipe and flowing east. View looking east.

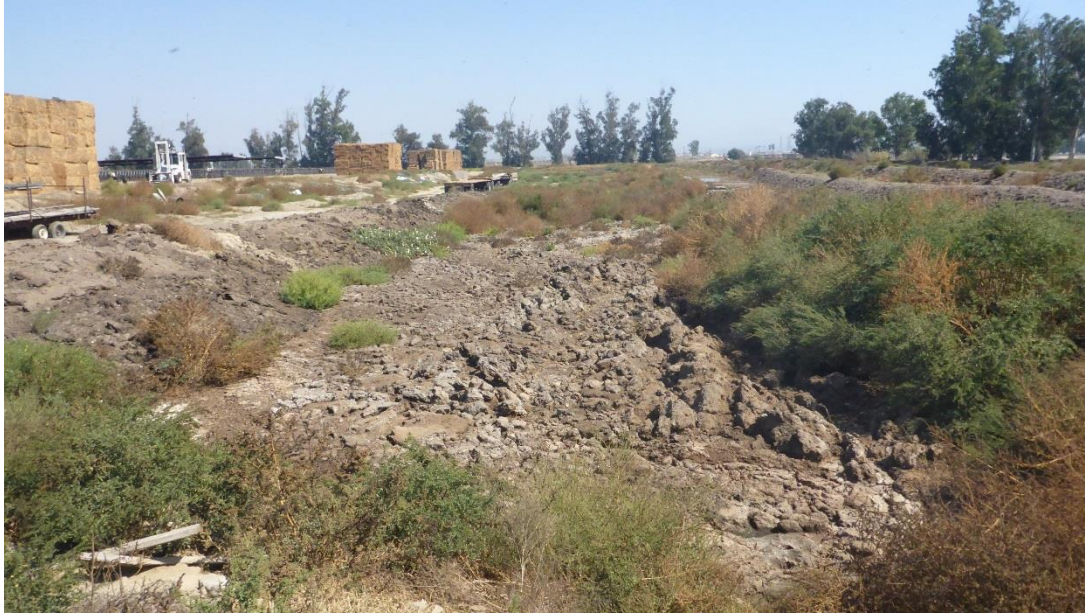
Photo 4: 1st (northernmost) bermed area with solids. View looking east.

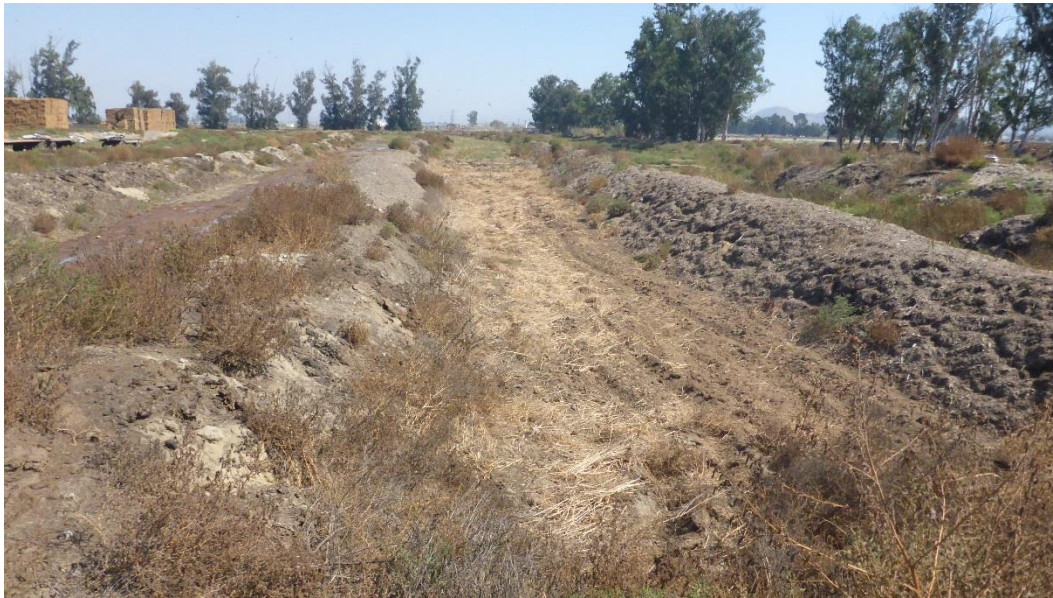
Photo 5: 3rd (from north) bermed area inactive after solids have been removed. View looking east.

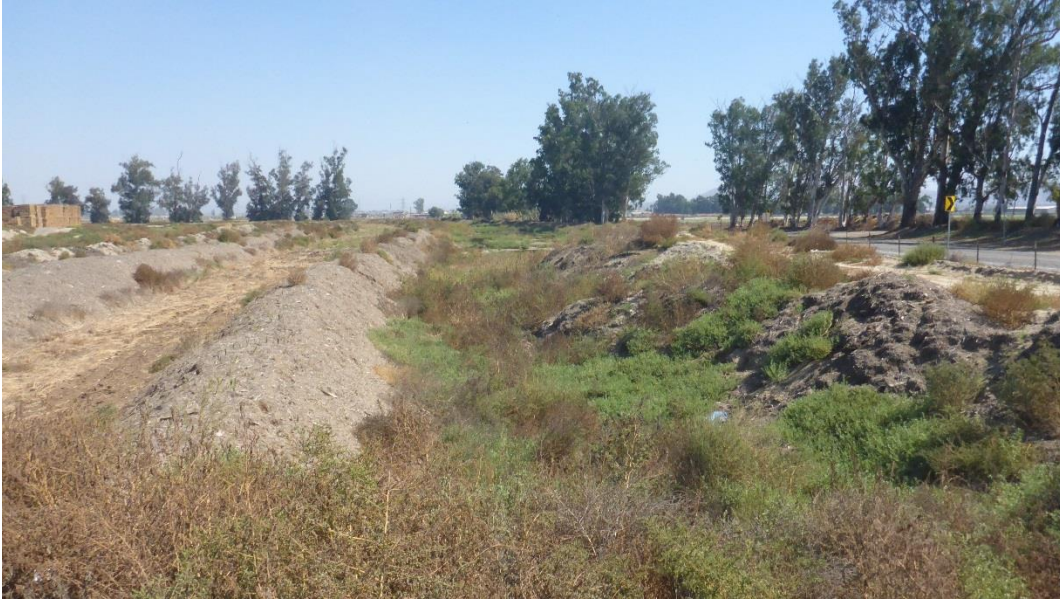
Photo 6: 4th (from north) bermed area inactive. View looking east.

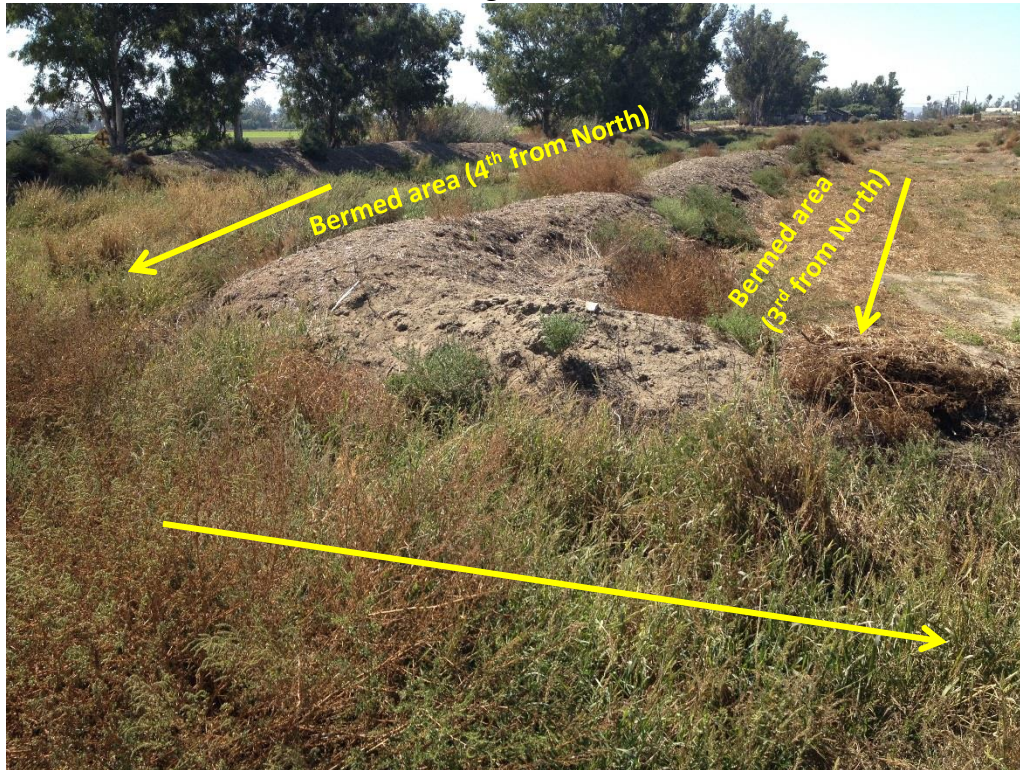
Photo 7: Southeastern edge of facility. Bermed areas turn corner and flow is directed northerward into ditch. View looking west.

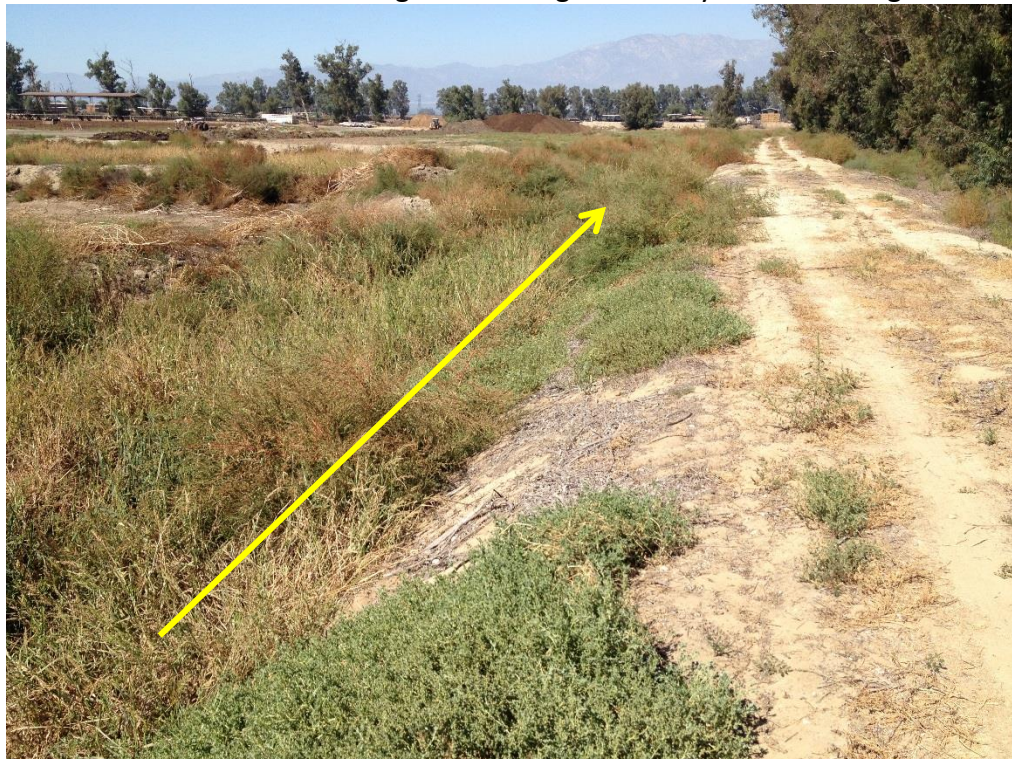
At the eastern end of the bermed areas, the berms are several feet lower to create a spillway into a ditch running alongside the eastern boundary (photo 8). The ditch was observed to contain heavy vegetation cover, especially in the southeast corner. The ditch directs wastewater northward back towards the center of the facility. At the end of the ditch, the operator has installed a pump (photo 10). When the ditch is full, the operator pumps wastewater to the northernmost disposal area where it infiltrates (photo 11). Excess wastewater from this pasture area may overflow to the center disposal area (photo 12).

Exterior berms appeared to be properly constructed. No rodent holes observed, minimal vegetation along tops of berms. Excess vegetation observed in ditches alongside berm.

Photo 8 : Ditch and berm along eastern edge of facility. View looking North.

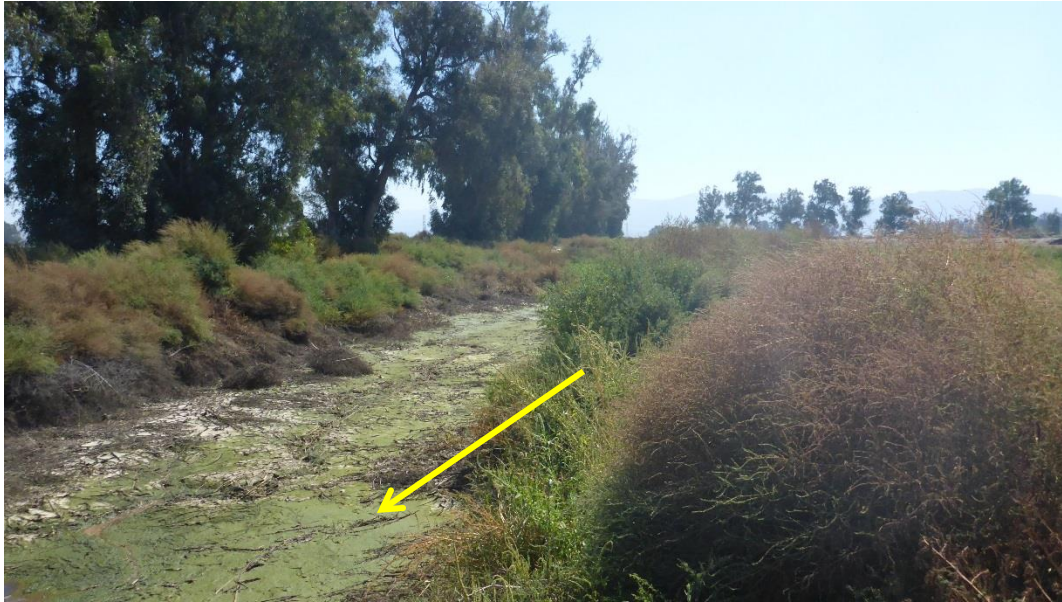
Photo 9: Ditch and berm along eastern edge of facility. View looking south.

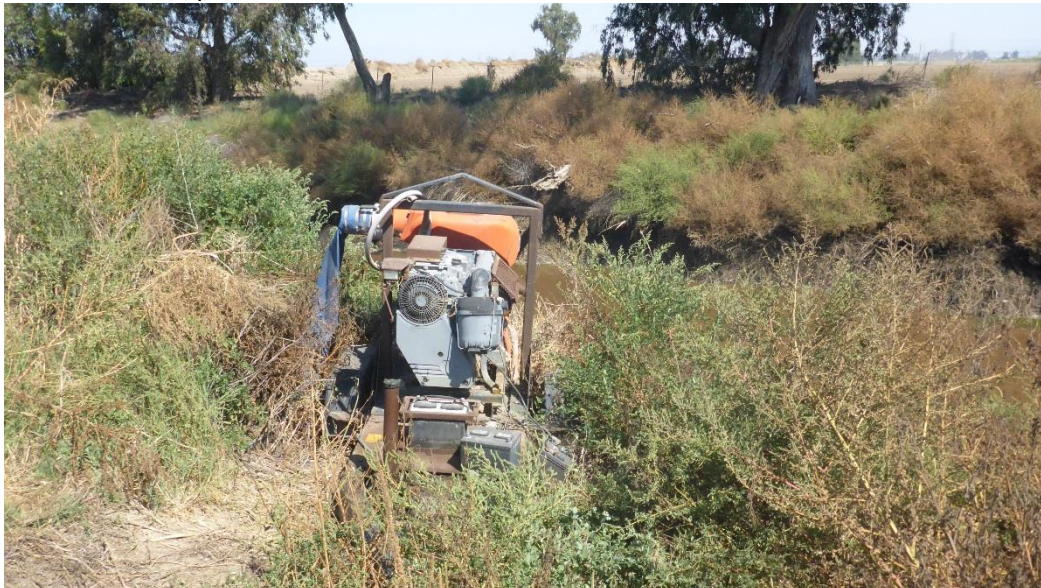
- The current configuration of the 4 bermed-areas, ditch, and pump are not included in the approved EWMP. The permittee does not appear to have notified the Regional Board in writing of changes to the EWMP.
- The ditch on the eastern border of the facility appeared to have excessive vegetation.

Photo 10: Pump in ditch

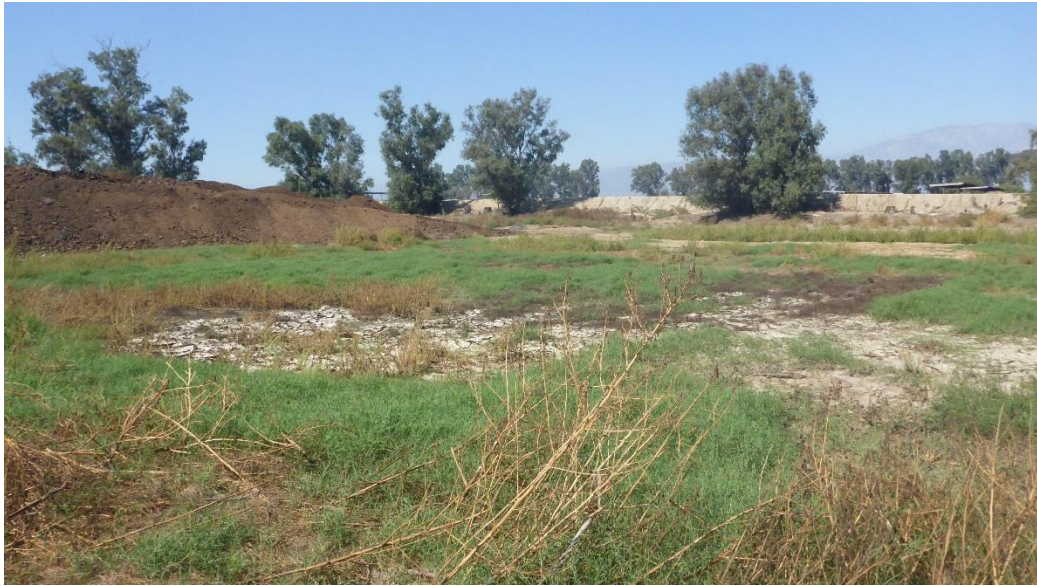
Photo 11: Disposal area adjacent to ditch for water pumped from ditch.

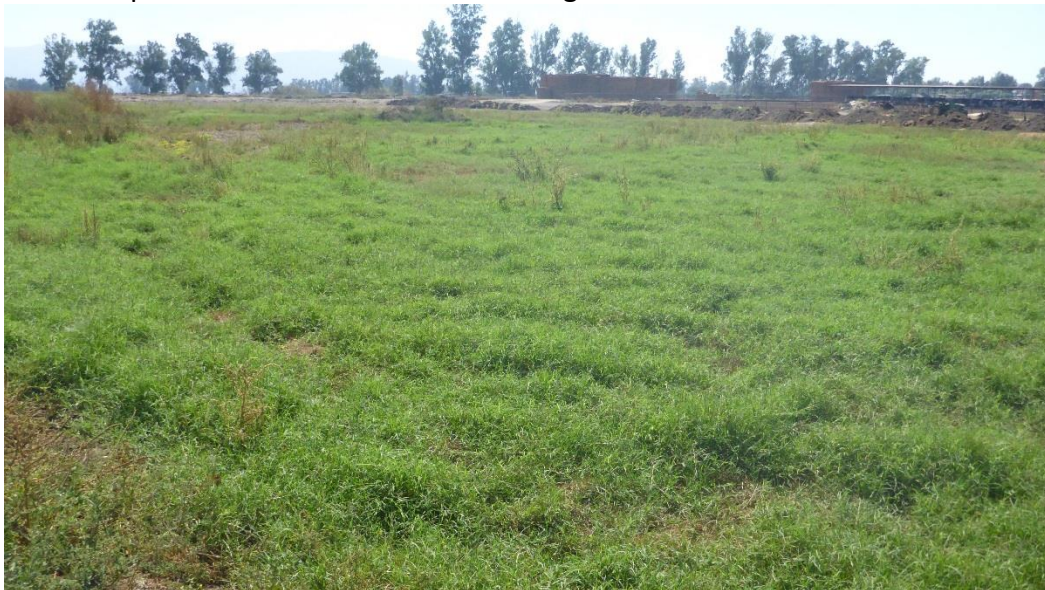
Stormwater generally flows from the corrals towards the center and easterly direction to the disposal areas (photo 12). The soils in the disposal area were observed to be sandy and very porous. The operator noted the high percolation rates in this area, and stating that 2' of water will drain overnight. The operator rips the disposal area as needed to encourage infiltration in this area. The operator recently bought a new disc ripper to facilitate ripping the area.

Photo 12: disposal area in center of eastern section of facility. This area receives stormwater flow from corrals, and receives any overflow from the disposal area in photo 11. The area is disked to promote infiltration. View looking northwest.
